FLIGHT TESTS OF VARIOUS TAIL MODIFICATIONS ON

THE BREWSTER XSBA-1 AIRPLANE

II - MEASUREMENTS OF FLYING QUALITIES WITH

TAIL CONFIGURATION NUMBER TWO

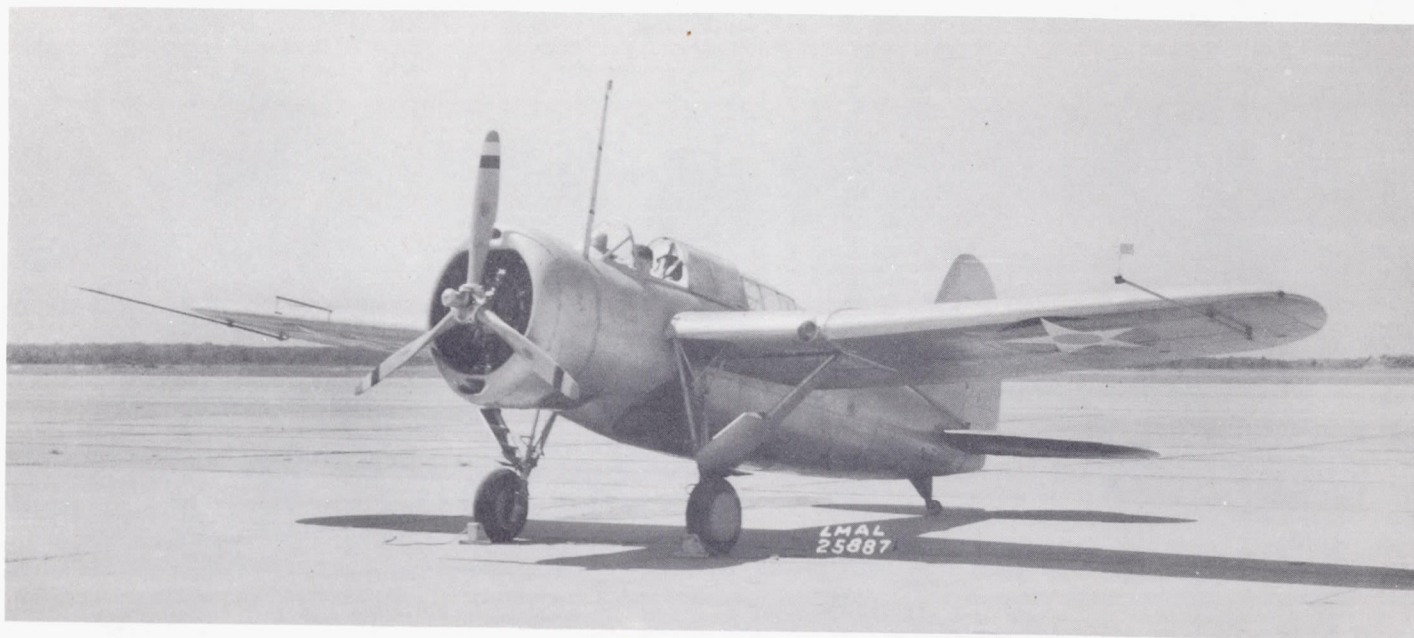
Figure 2.- Three-quarter front view of Brewster XSBA-1 airplane.

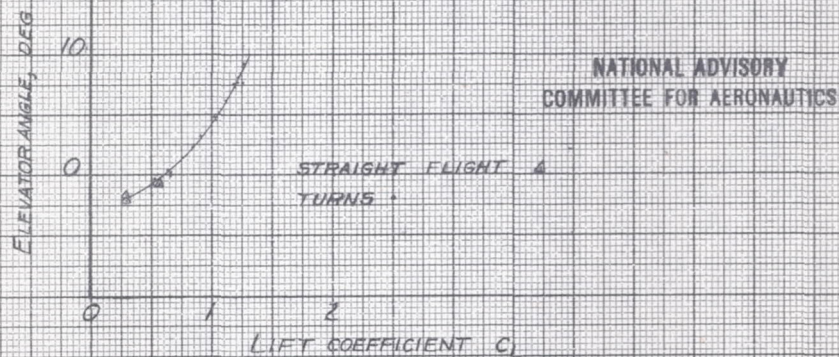
Figure 22.- Variation of elevator angle with lift coefficient in  $180^\circ$  turns.
